**TRANSPORTATION SCIENCES CENTER  
ACCIDENT RESEARCH GROUP**

**CALSPAN CASE NO. CA94-31**

**VEHICLE #1 - 1992 TOYOTA CAMRY LE  
DRIVER SIDE AIR BAG  
DRIVER FATALITY**

**ON-SITE INVESTIGATION**

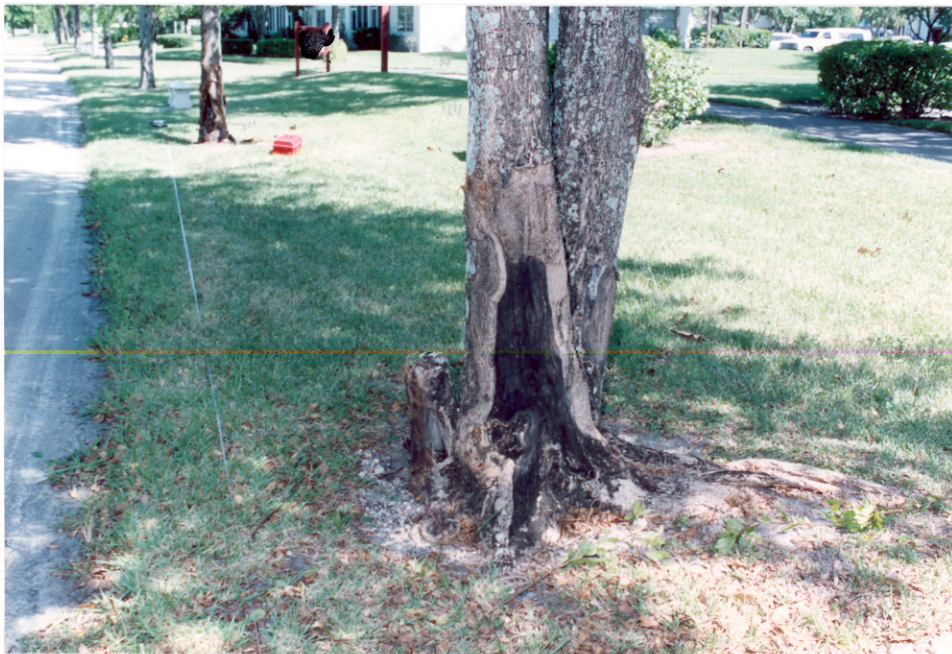
The vehicle departed the right side of the road (the south roadway edge), traveled over the adjacent grass shoulder and struck a small tree stump (refer to photograph # 8 on page A-4) with the right front tire and lower side plane. This resulted in deformation of the wheel and sideswipe damage down the right side of the vehicle. The vehicle continued in a straight trajectory for 10.5 m (35') and struck a 28.9 cm (11.1") diameter black olive tree with the center frontal plane. The vehicle rebounded approximately 0.9 m (3.0') rearward to its final rest position (FRP) as shown in on-scene photographs #13 and #14 on page A-7. There were no pre-impact skid marks present in the grass shoulder prior to the first impact.

8. POI with tree stump located left of the main tree trunk.

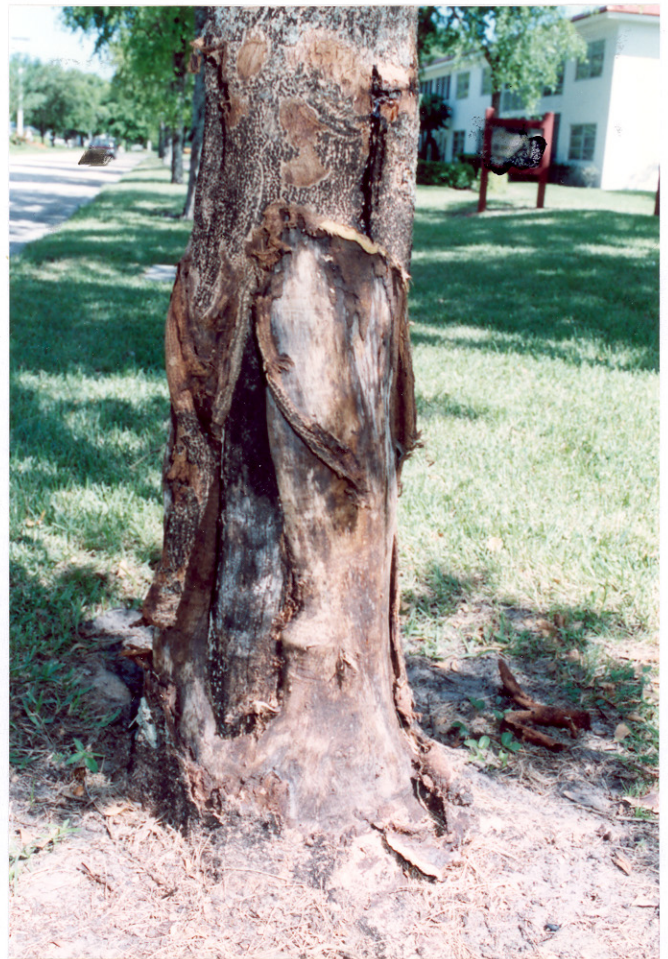
The second impact sequence involved the frontal plane of the vehicle and a 28.3 cm (11.1") diameter black olive tree. Direct contact began 7.6 cm (3.0") right of the vehicle centerline and displaced the bumper rearward 78.5 cm (30.9") at maximum crush. Components damaged in the crash included: the bumper; grille; hood; both front fenders; radiator; left and right headlight assemblies; windshield; and roof (refer to photographs #18-#32 on pages A-9 through A-16). The left side wheelbase was reduced in length by 13.0 cm (5.1") and the right side wheel base was reduced 2.0 cm (0.8").

12. POI with second tree (Black Olive) which was 28.3 cm (11.1") in diameter.

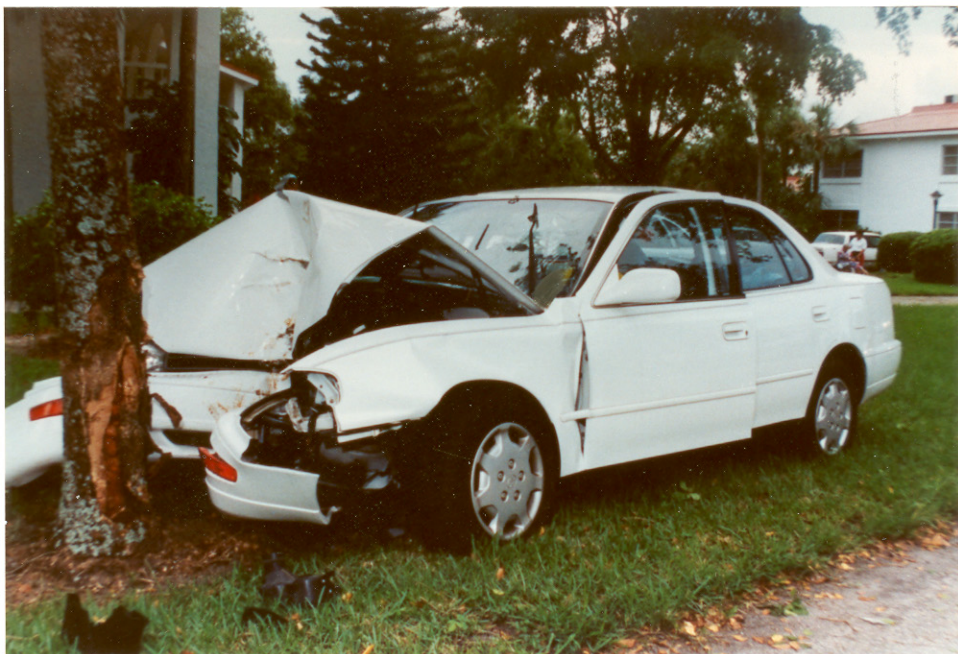
Prior to the crash site, the vehicle traveled through a section of the roadway which was reportedly being sprayed by errant lawn sprinklers. It is unclear whether the water from these sprinklers distracted the driver and required her to turn on the windshield wipers as the windshield wiper arms were noted in a vertical position at the vehicle's final rest position (FRP) as shown in photograph #14 on page A-7.

14. On-scene view of Vehicle #1's FRP relative to the tree and roadway edge.

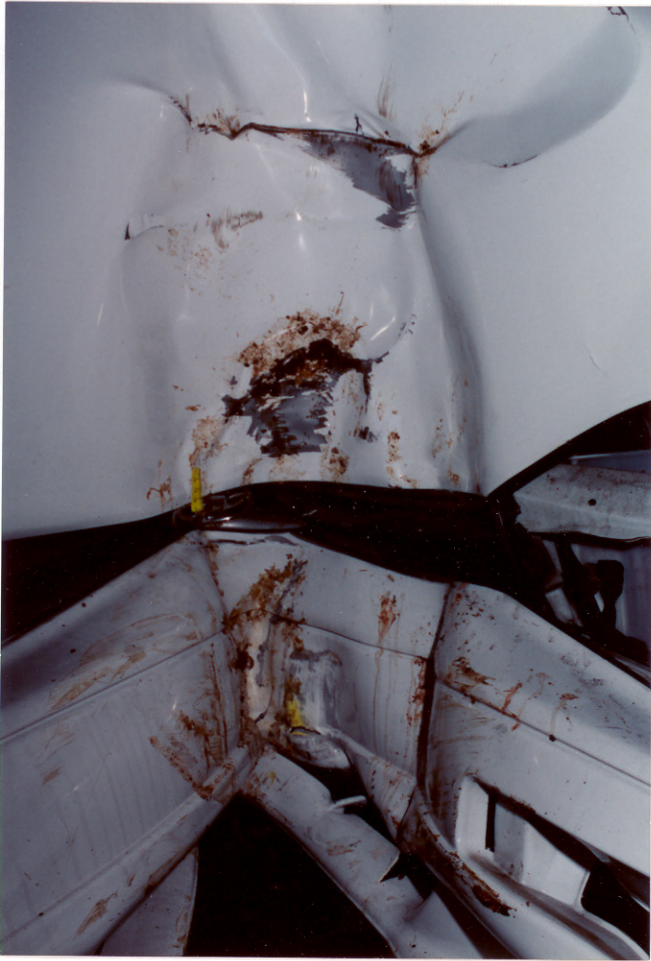
19. Close-up view of the frontal impact with the second tree.

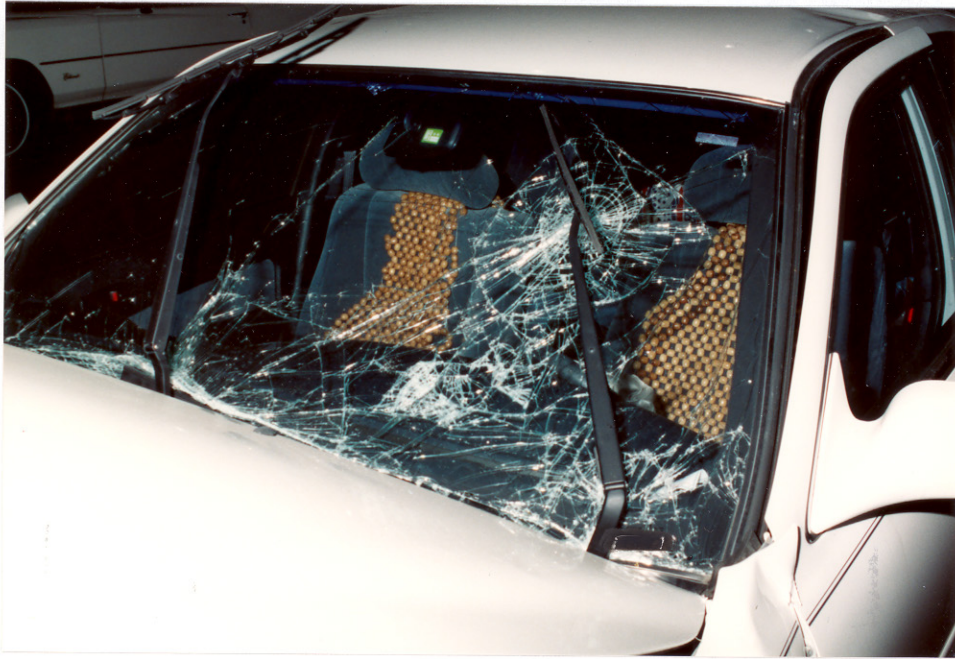
The left side of the windshield contained a typical spider web glazing fracture pattern which was the result of contact by the driver's left hand. It was located 39.4 cm (15.5") left of the vehicle centerline and 20.3 cm (8.0") above the instrument panel (refer to photograph #40, #41 on pages A-20, A-21).

25. View of the windshield from the left side which shows a spider web pattern which resulted from contact by the driver's left hand during the second tree impact sequence.

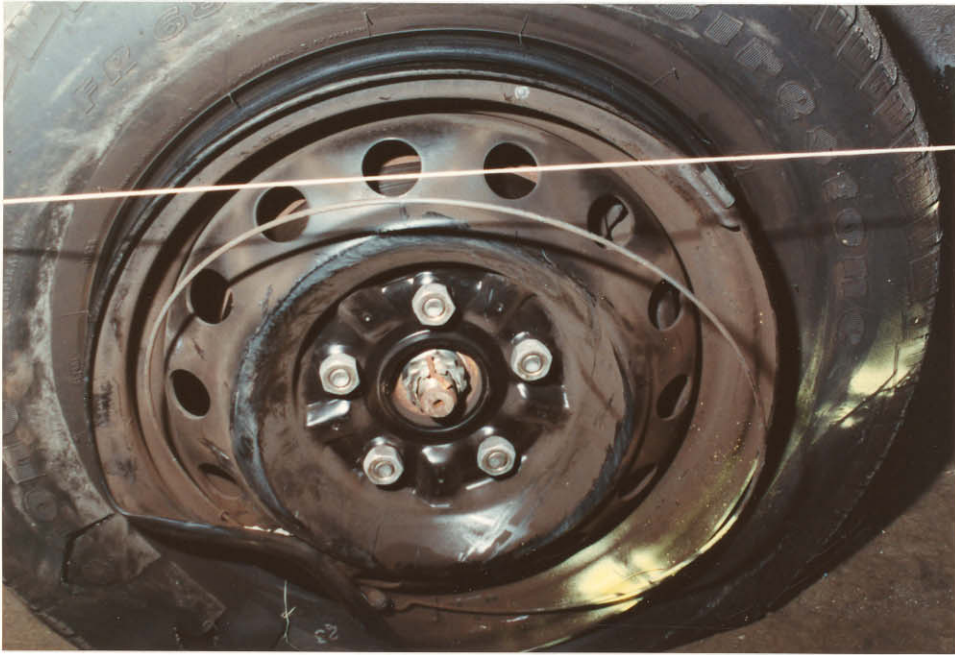
Vehicle #1 struck a small tree stump which measured 40.6 cm (16.0") high that was located at the base of a larger tree with the right front tire. This contact damaged the tire and deformed the wheel. The tree stump contact damage continued along the lower right side plane in a sideswipe pattern for a distance of 245.1 cm (96.5") where it ended forward of the right rear wheel. Vehicle #1 continued in a straight trajectory for 10.5 m (35') and struck a 28.9 cm (11.1") diameter black olive tree with the center frontal plane. This impact resulted in the actuation of the SRS.

31. Close-up view of the right front tire and wheel highlighting deformation from the impact with the tree stump.

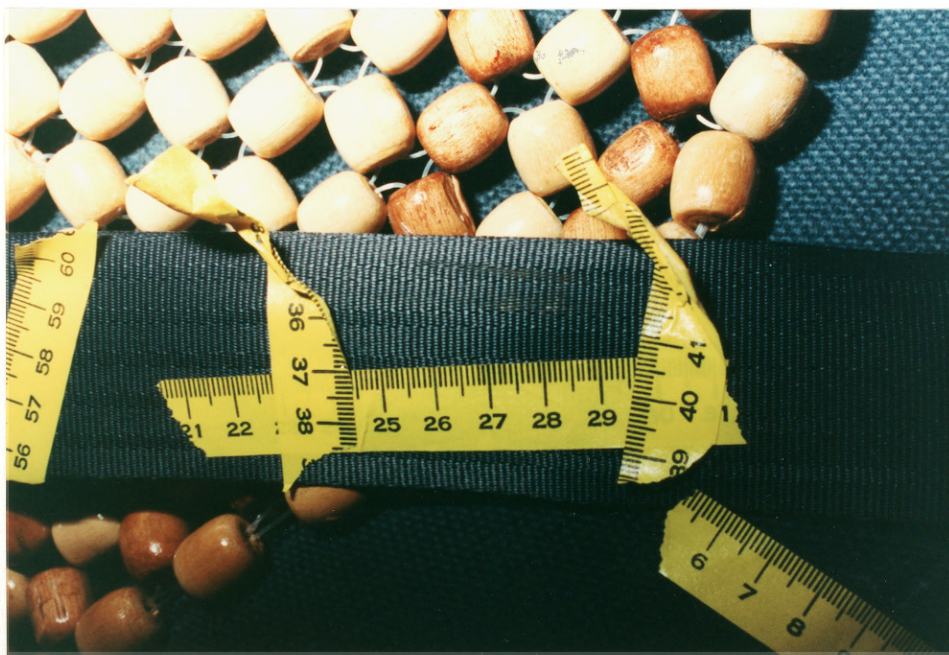
38. Close-up view of a 1.3 cm x 5.0 cm (0.5" x 2.0") light yellow transfer and abraded surface of the driver side torso belt located 44.5 cm (17.5") from the "D" ring.

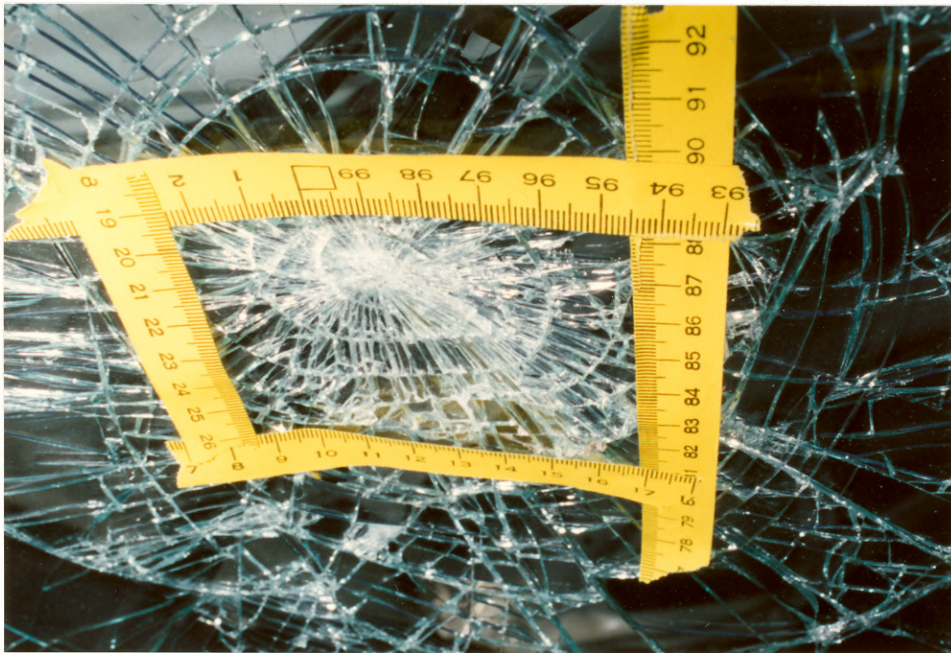
41. Close-up view of the contact to the windshield by the driver's right hand.

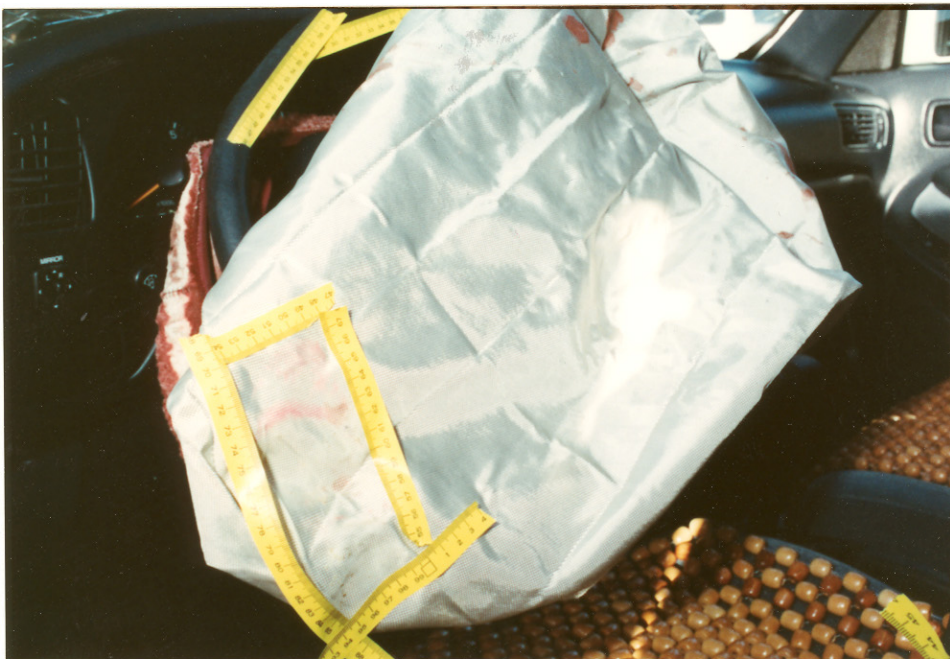
The driver sustained multiple facial abrasions (i.e., nose, left eye lid and cheek, lips, chin and right lower cheek) which were attributed to contact with the air bag. Red lipstick and tissue transfers observed in the upper left quadrant of the air bag correlated with these injuries.

Two red lipstick imprints and a tissue transfer were noted on the air bag in the upper left quadrant near the periphery (refer to photograph #42 on page A-21). These contact marks covered an area which measured 5.1 cm (2.0") laterally and 11.4 cm (4.5") vertically. This was attributed to contact with the driver's facial/chest area during the SRS deployment sequence.

42. Close-up view of red cosmetic and tissue transfers in the upper left quadrant of the air bag.

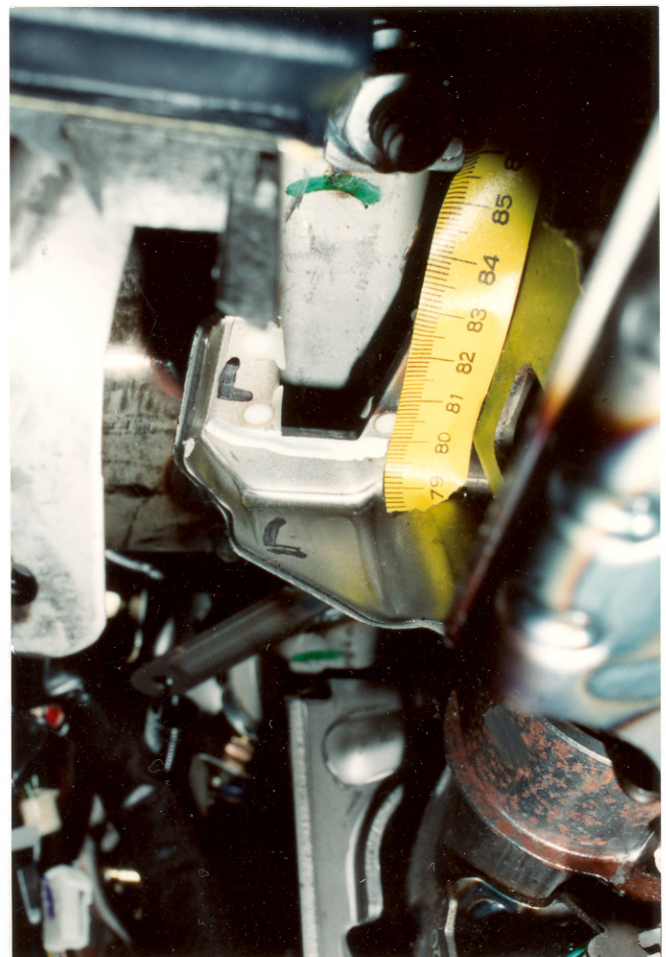
44. View of the left steering column shear capsule/shear plate showing 5.3 cm (2.1") displacement.

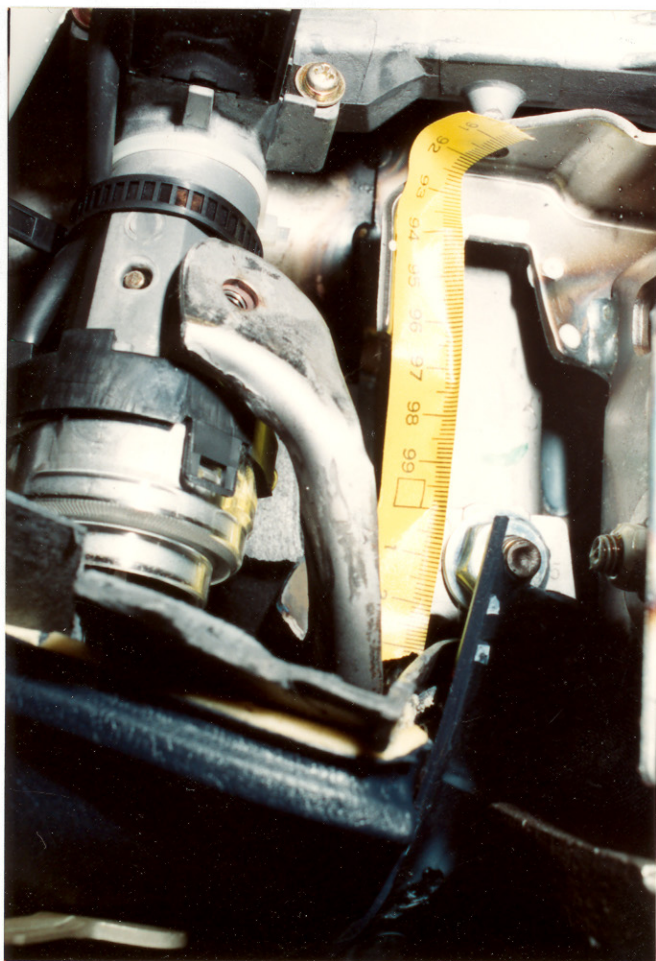
45. View of the right steering column shear capsule/shear plate showing 5.8 cm (2.3") displacement.

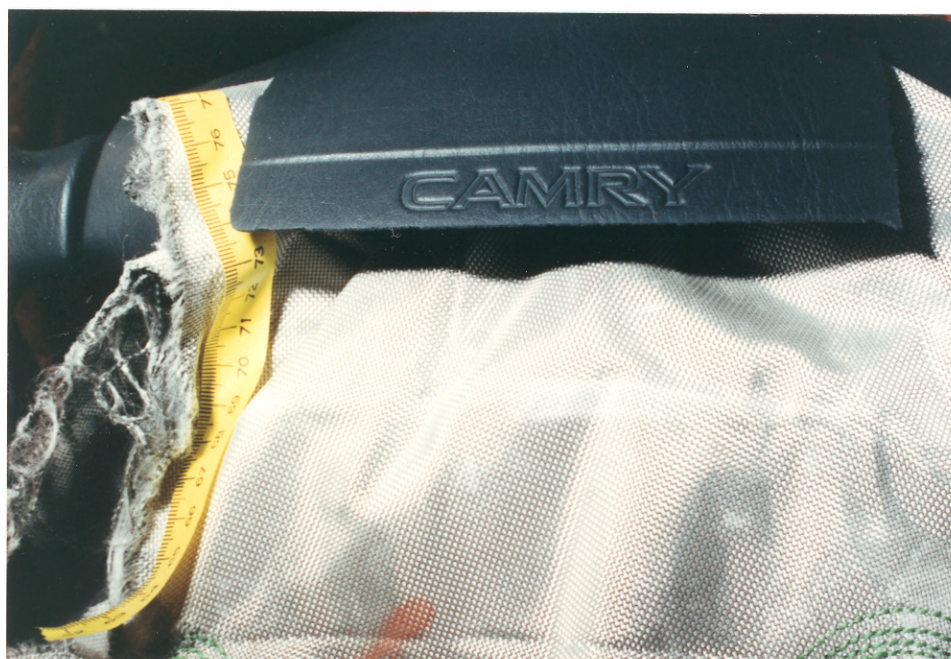
48. View of the upper flap of the air bag module cover with the tear in the air bag noted along the left side of the photograph.

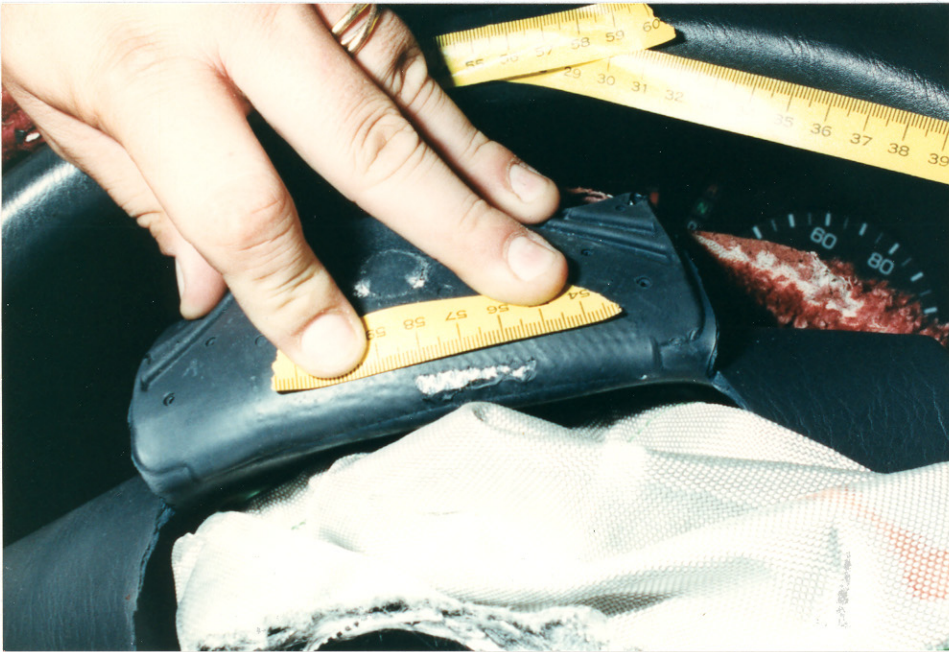
The driver side air bag and air bag module air bag were damaged during the deployment cycle which was attributed to contact by the driver's upper torso. The underside of the upper flap of the air bag module cover was abraded over a 2.5 cm (1.0") area located 6.0 cm (2.4") right of the left vertical edge and 6.4 cm (2.5") above the horizontal tear seam line (refer to photograph #49 on page A-25).

49. View of the underside of the upper air bag module flap showing an abraded area measuring 2.5 cm (1.0") in length.

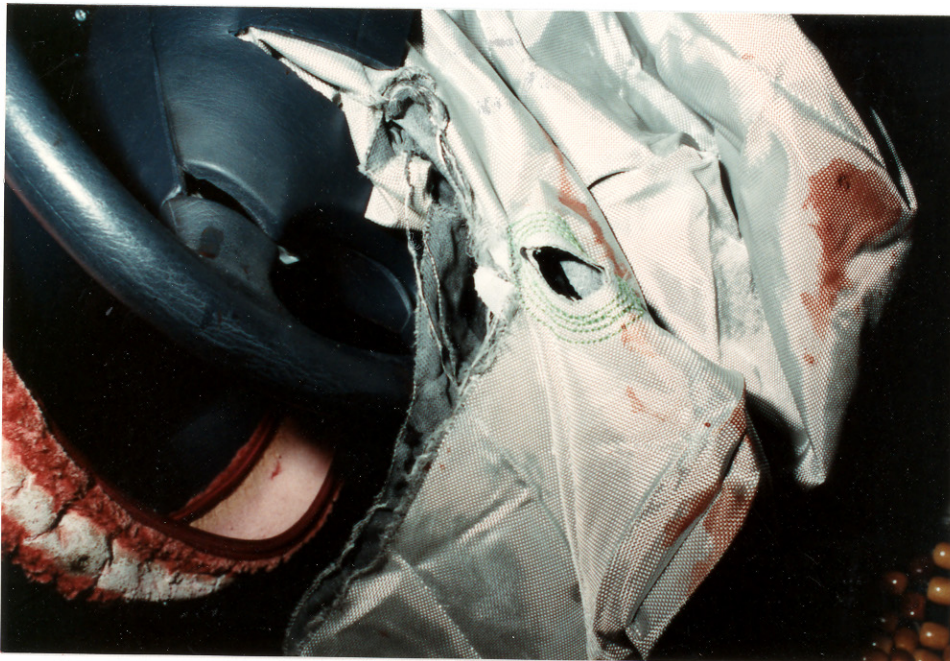
The air bag was torn on the instrument panel surface along the left upper quadrant. The tear measured 35.6 cm (14.0") in length and extended from the left vent port downward (refer to photographs #52-#54 on pages A-26, A-27). The cause of the tear appeared to have been the result of interaction by the expanding air bag with the air bag module compartment wall and air bag module flap.

The driver's contact with the air bag module cover during the SRS deployment sequence partially trapped the air bag against the air bag module flap and air bag module housing as the air bag was expanding. The combination of events which involved loading by the driver and expansion of the air bag more than likely resulted in the rupture of the air bag fabric. There were no disruptions or irregularities evident along the flaps or module housing which were identified as contributing to the tearing event.

52. View of the left side of the air bag showing the location of the tear.

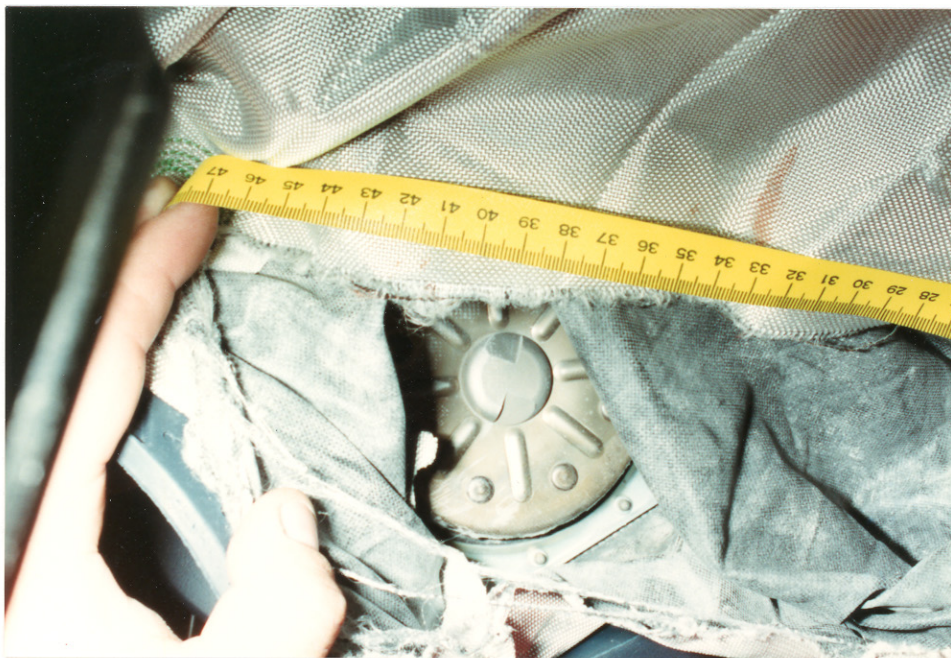
54. Tear in the air bag opened to show the air bag inflator.

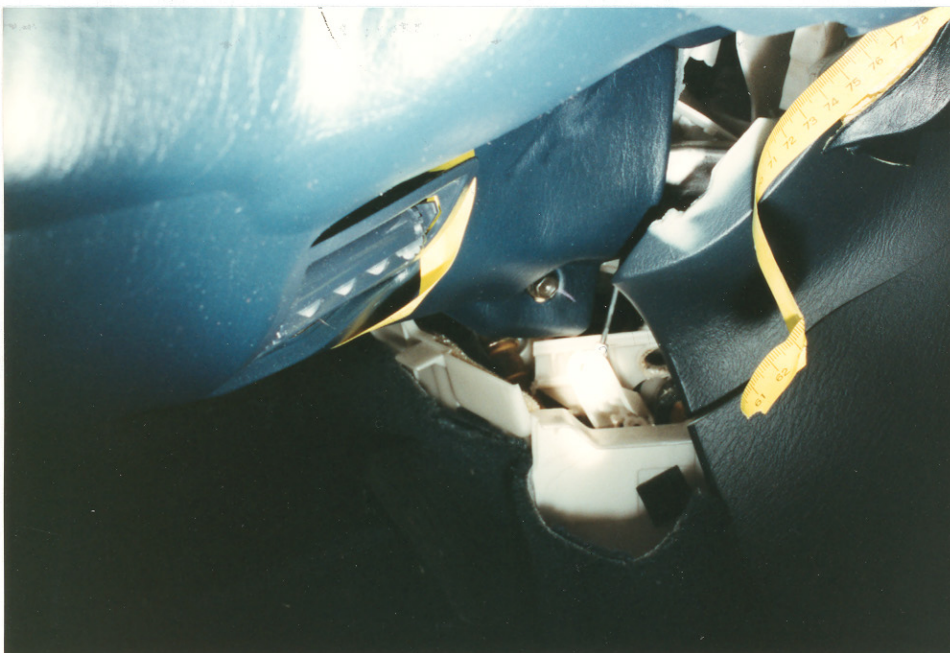
57. View of the contact damage by the driver's right leg along the lower instrument panel and knee bolster located right of the steering column.

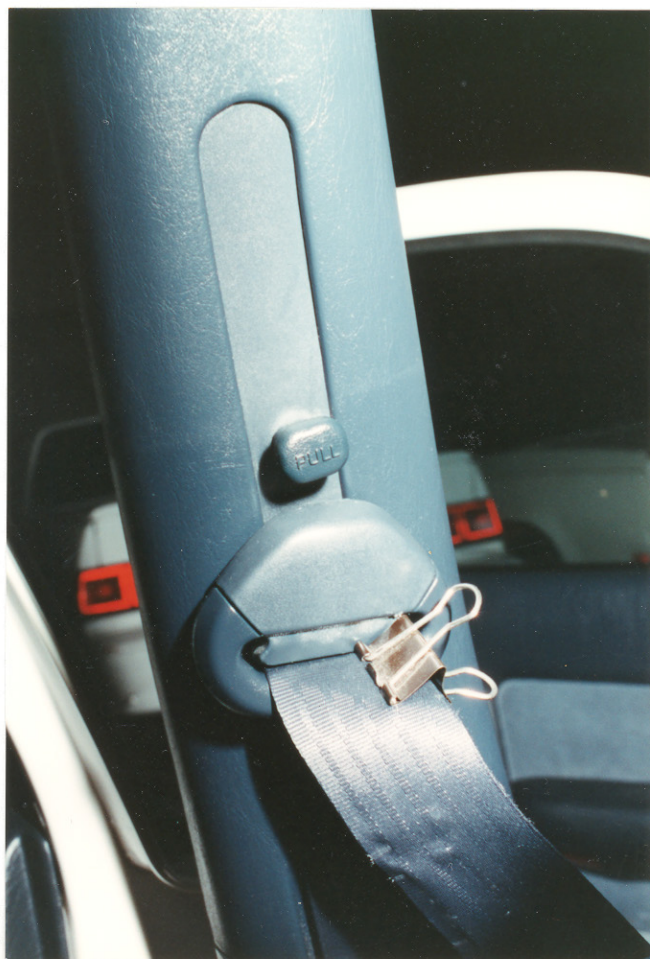
The driver was improperly restrained by the manual lap and torso belt prior to the crash. The torso belt was positioned under the driver's left arm with a paper clip attached near the D-ring to limit the belt spool up mechanism. Her hands were placed on the steering wheel rim in the ten o'clock and three o'clock positions as determined by occupant contact points on the windshield and center instrument panel. Her right foot was probably located on the accelerator pedal at the time of the first impact sequence due to the lack of pre-impact braking marks noted by the police.

62. View of the paper clip used to limit belt spool-up capability by restricting movement of the torso belt at the D-ring. Additionally, this photograph shows the height adjustment of the D-ring was at its lowest limit during the crash.
